First Five-Year Review Report

Taylor Road Landfill

Hillsborough County, Florida

September, 2003

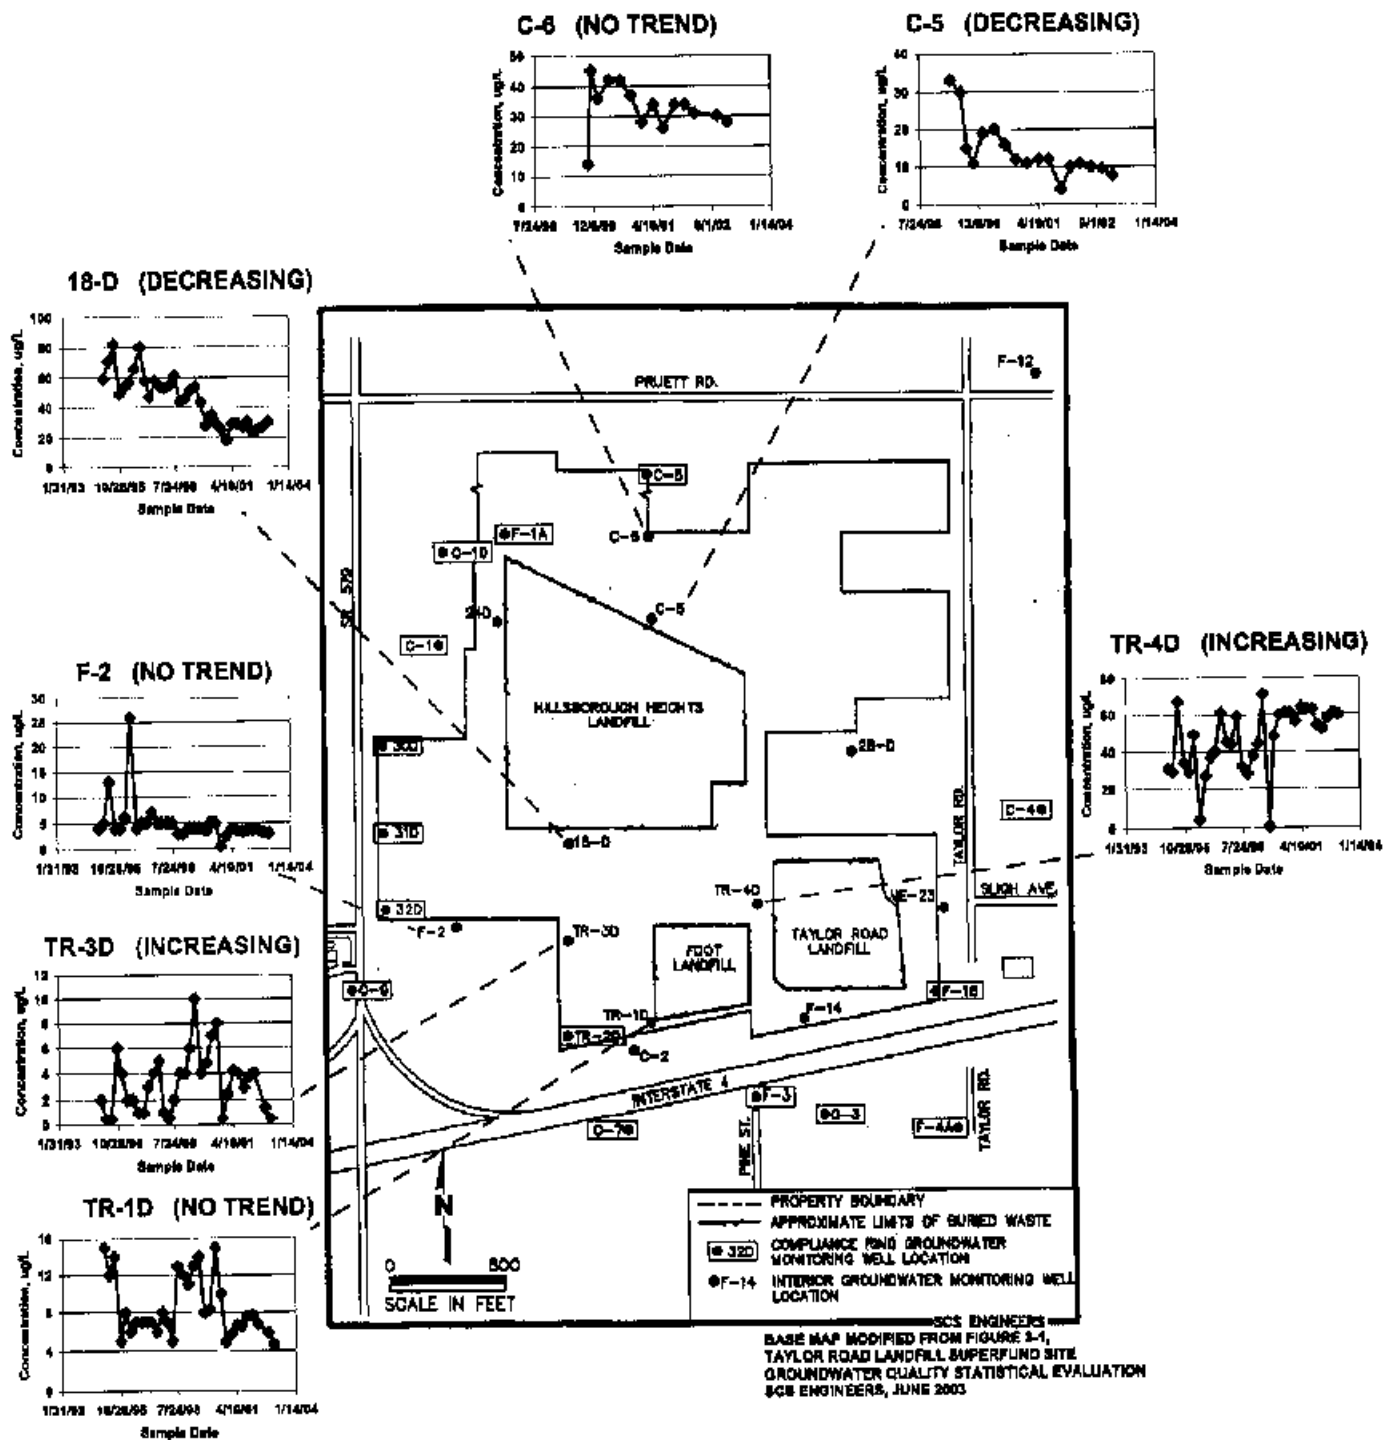
Figure 3. cis 1,2-Dichloroethene Concentration Trends

The concentration trends for cis 1,2-DCE are shown on Figure 3. Wells shown on this figure have either had cis 1,2-DCE at concentrations above the remediation level or have otherwise had repeated detections of this contaminant. Although recent concentrations of this contaminant have not exceeded its 70 ug/L standard, this contaminant can be degraded to produce vinyl chloride, which has a 1 ug/L remediation level.

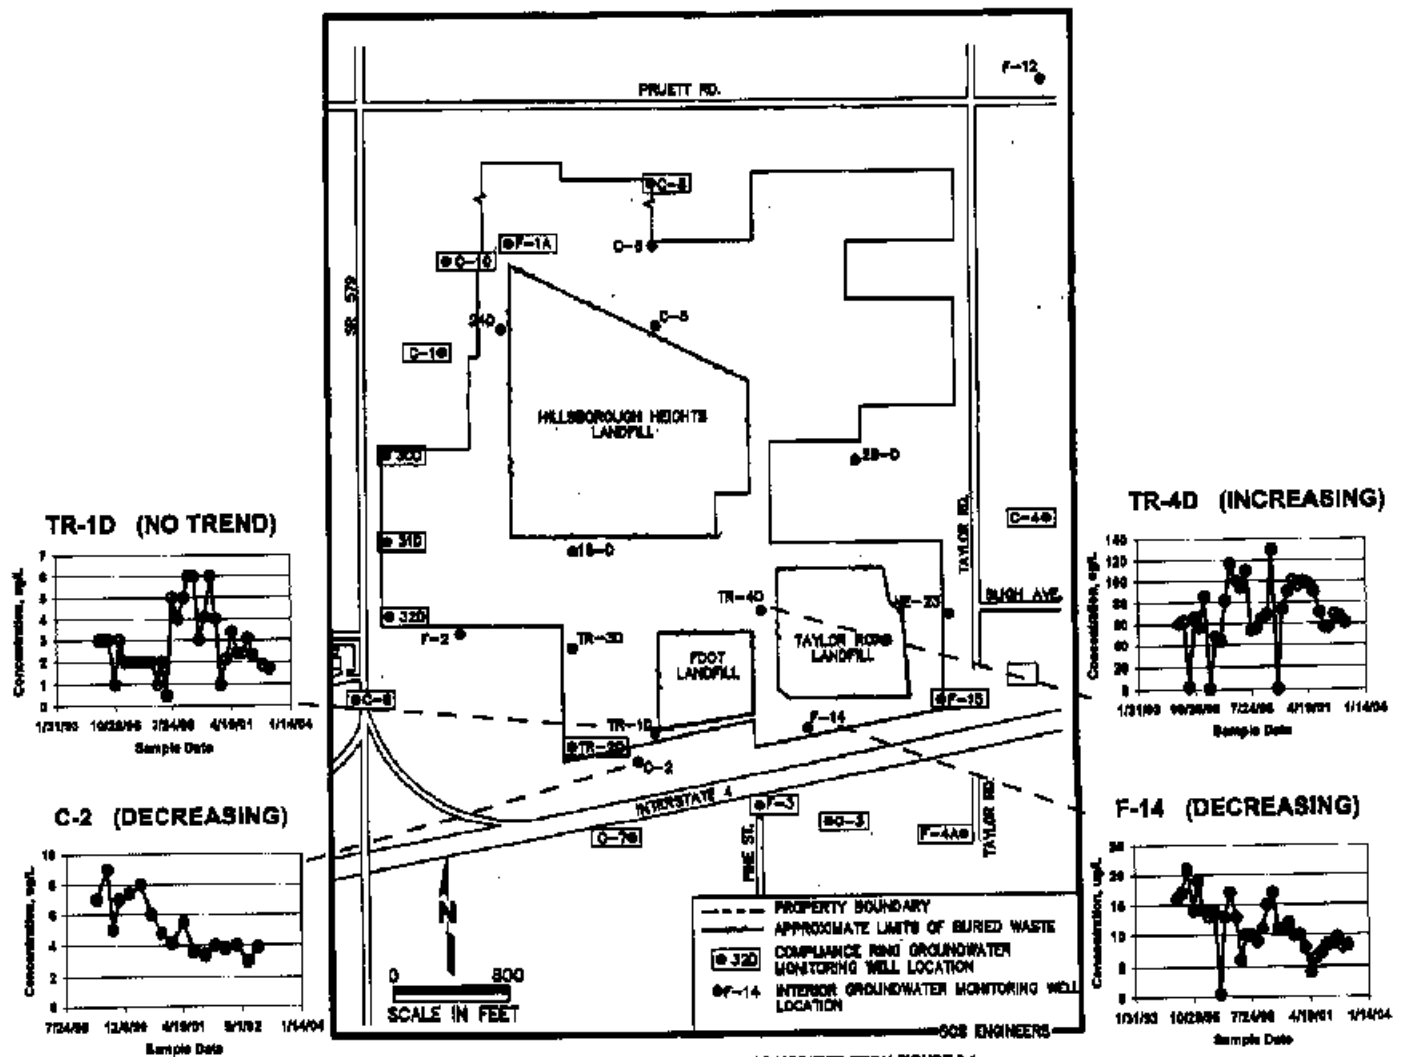
Figure 5. 1,1-Dichloroethene Concentration Trends

Figure 5 shows the time-concentration data for 1,1-DCE. Well TR-4D, with the most significant concentrations of 1,1-DCE, has shown a statistically significant increase in concentrations over time. However, the most recent samples from this well suggest either a decreasing concentration trend, or possibly that the maximum concentrations at this well have already been observed. 1,1-DCE is not a concern at any compliance monitoring well.

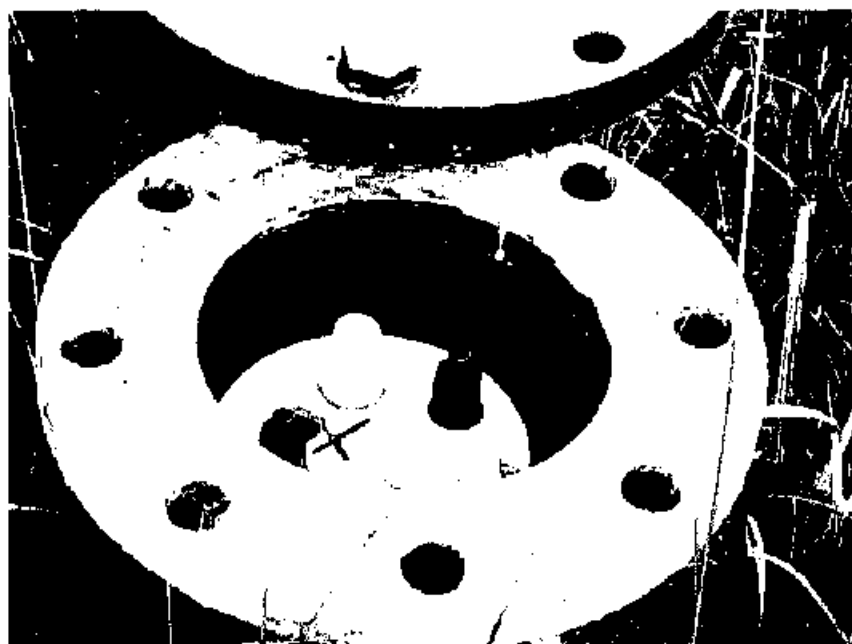
Taylor Road Landfill: Deep monitoring well with protective casing and dedicated sampling system.
